Stuart Still, Technical Support Co-ordinator at EEC, was recently called to a garage in Scotland to help overcome an issue associated with the cat efficiency light. This article highlights the problem and how it was resolved.

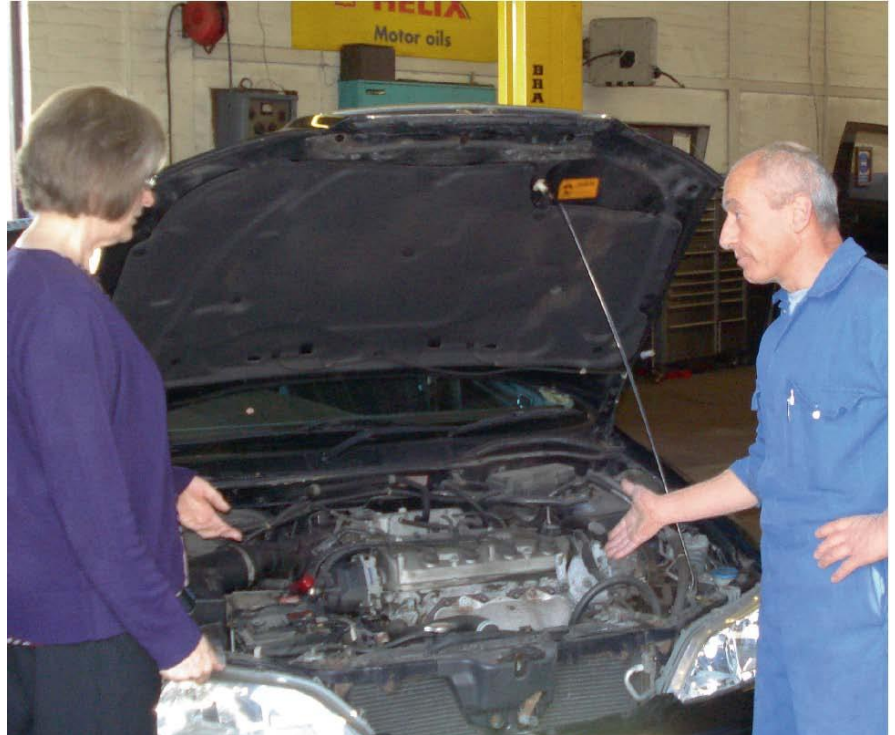
Iain had assumed the catalytic converter must be faulty, but this is not necessarily the case. The reason the cat efficiency light came on is that the rear Lambda sensor was detecting a higher proportion of O₂ than was actually entering the catalytic converter. There should be less O₂ exiting a catalytic converter than enters it!

With this in mind we had to identify the Source of the extra O₂. I concluded that the location would be between the two Lambda

sensors, which I was able to deduce from the fact that if the source was before the first Lambda sensor, the HC's would be far higher, thus allowing the Lambda sensor to pick up the extra O₂. Therefore the sensor would think that the mixture was lean and the ECU would compensate for this by increasing the fuel. If the extra O₂ source is located after the second lambda sensor the cat efficiency light would not be on, as all of the emissions values are correct. The source of the unwelcome O₂ was due to a damaged pipe between the first and second Lambda sensors and once this was rectified, the warning light went out. I then explained to Iain how to evaluate the emissions values from his 4-gas analyser, and also how to diagnose, locate and remedy any faults.
